NEW
MANUAL

1ST MEET
T-18
CONCLAVE
FOR
S.W.
REGION

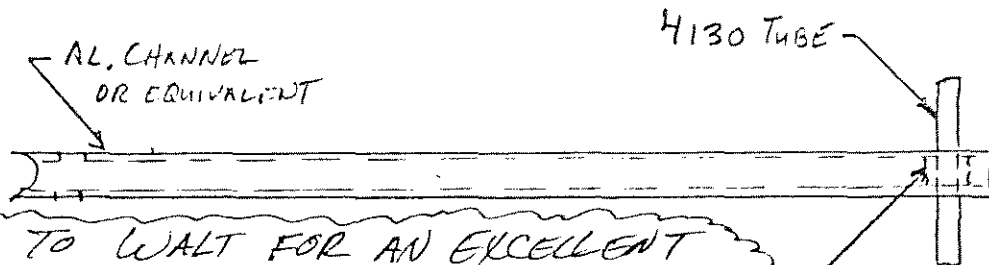
FROM — WALT GIFFIN - NT8WG

NOT TO SCALE

"THANKS TO WALT FOR AN EXCELLENT DRAWING. THIS IS SOMETHING ALL T-18 OWNERS NEED."
DICK

(3) HANDLE
