T-18 NEWSLETTER

ISSUE NUMBER 82

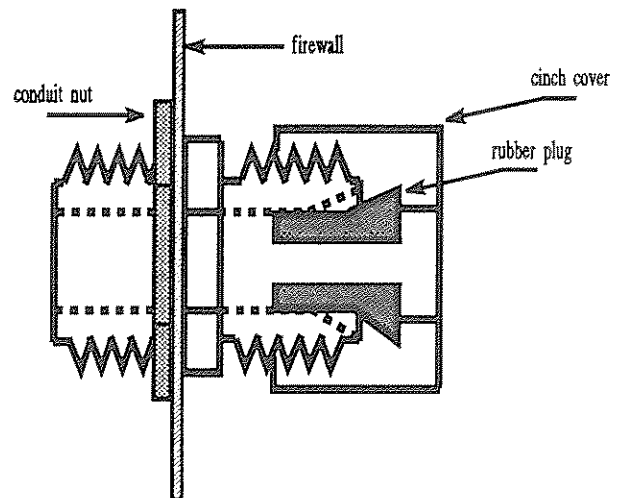
CORD GRIP

Cord grip labels, you pick the grip range to suit the application. They also come in right angle models that would be nice for large wire bundles.

This building tip came from Cliff Redden of Georgetown, Ohio and it's covers a small electrical device called a Cord Grip that makes about the nicest firewall feedthru for wires or throttle/mixture cables that you can get. They are made of aluminum with a rubber insert sized for electrical cords. They look a little like a pipe bulkhead fitting with a standard electrical conduit size with a conduit nut for connection to the firewall. As the cover is tightened down the rubber is compressed against the cable or wire for a tight fit. I put a small piece of abestos in them on the firewall side for fire protection. For the throttle/mixture control feedthru I turned them around backward which put the rubber and it's cover on the inside of the fuselage, this gave me about another inch for the cables to move with the engine bracket that attaches to the carb.
